Bringing Bhutan's Dying Water Sources Back to Life

Spring Revival Project

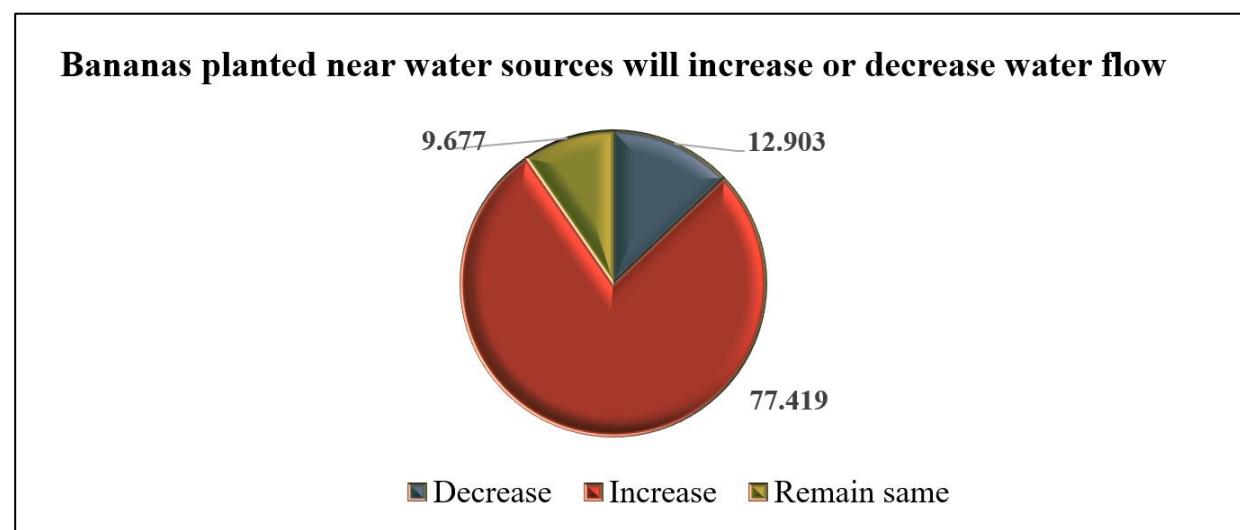
Table 3.1: Perception on banana planting intervention to increase water flow

To check this assumption, a questionnaire was conducted to reveal the local community's understanding of how banana contributes to the increase or decrease of water flow. The assessment found out that 77.419% of participants believed that banana would result in an increase in water flow, while 12.903% believed that banana is causing the spring to decrease flow (Figure 3.1). This shows a clear divide in the understanding of the impact of banana on water flow.

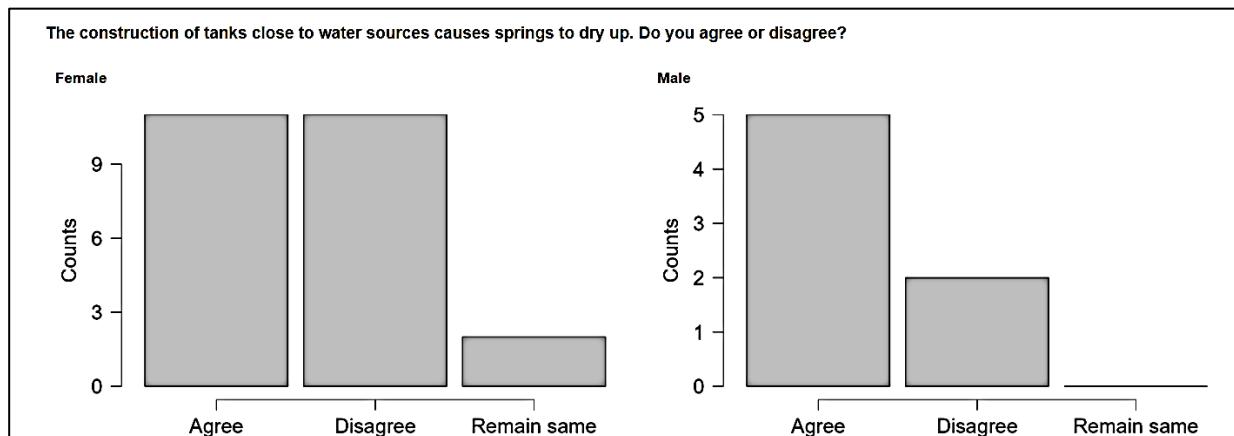
Table 3.2: Confusion on tank placement causing source drying

The analysis of the responses showed that females had a balanced opinion on the issue of drying up and not drying up while constructing water tanks near the water sources as shown in table 3.2. However, males had a skewed opinion where most of them thought that constructing water tanks near the source resulted in the drying up of water.

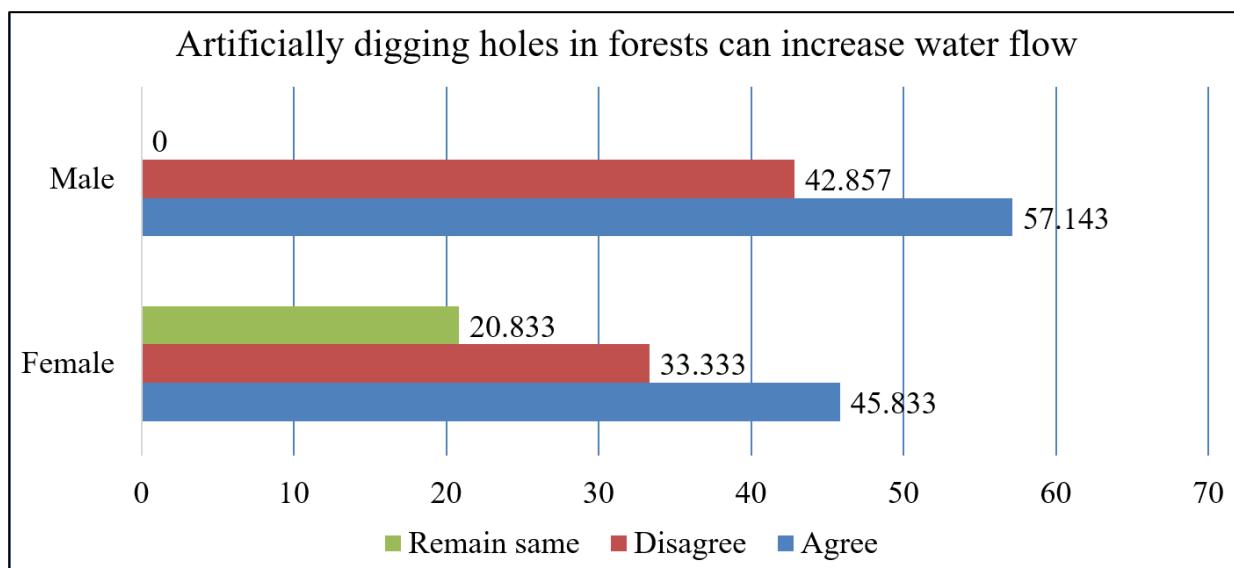
Table 3.3: Confusion on tank placement causing source drying

The intervention in this study involved digging contour trenches on recharge areas for harvesting the rainwater in the forest. To assess the effectiveness of this intervention, the assessment was conducted before the implementation of the intervention. The survey aimed to understand the perception of the local community on whether artificially digging holes in the forest could increase spring water flow. The survey revealed that many males and females felt that creating recharge pits could benefit the spring water flow as shown in figure 3.3.

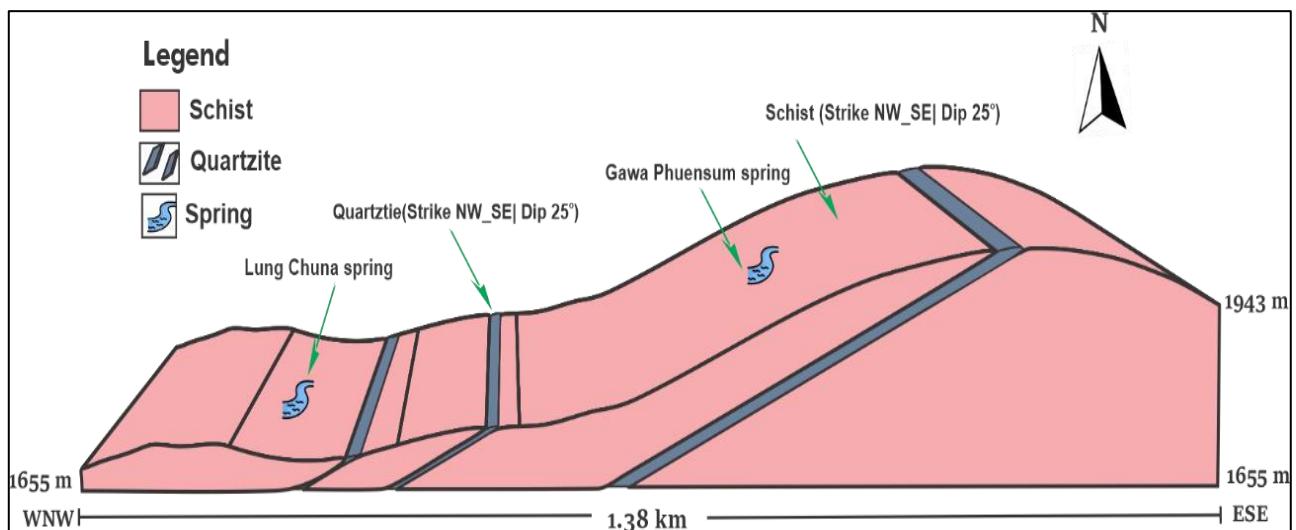
Figure 3.5: Hydrogeological layout of the Lungchuna and the Gawa Phuntsum spring source

The study revealed that Lungchuna spring, which originates in a chirpine forest, has been drying up since 2002, along with the nearby Gawa Phuntsum spring. This indicates the urgent need to revive these springs, which can be initiated by demarcating recharge areas in the springshed. The moderately forested recharge area of Lungchuna spring is also covered with thick trees, providing fewer open spaces for interventions. The recharge area is located on a steep slope, and the intervention was carried out in areas that were moderately inclined above the spring, just above the cliff, to reduce the chances of flooding. The entire springshed is composed of schist with thin layers of quartzite rock and a thick layer of soil and grassland on top. The marking of rock outcrops was challenging due to their rare visibility on the surface. However, the study used river transects to map the rock strata, which were found to be dipping from 25 to 45 degrees to the southwest.

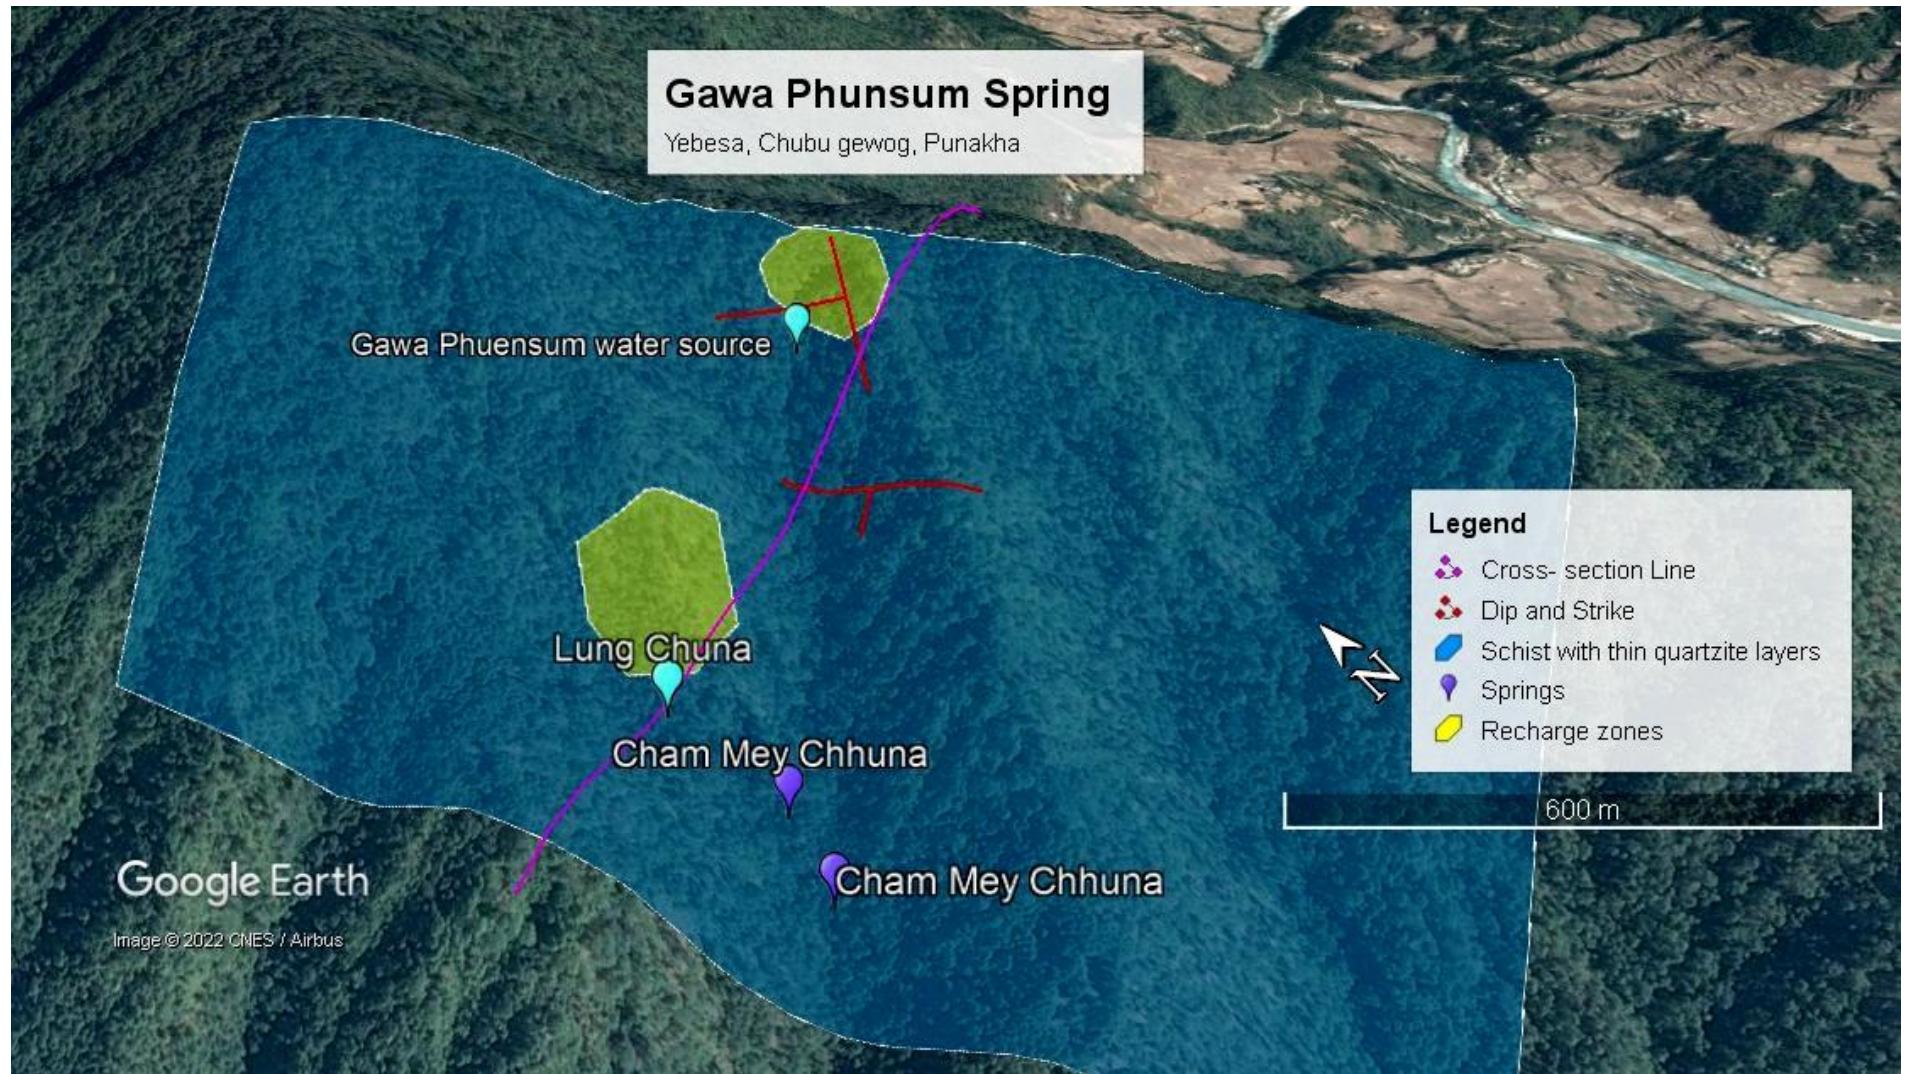
Figure 3.8: Location of the recharge area of the Lungchuna and Gawa Phunsum spring source on Google Earth

Centre Coordinate of Recharge Zone: **UPPER** 27.638401, 89.839503, 1920 masl; **LOWER** 27.636614, 89.834926, 1731 masl

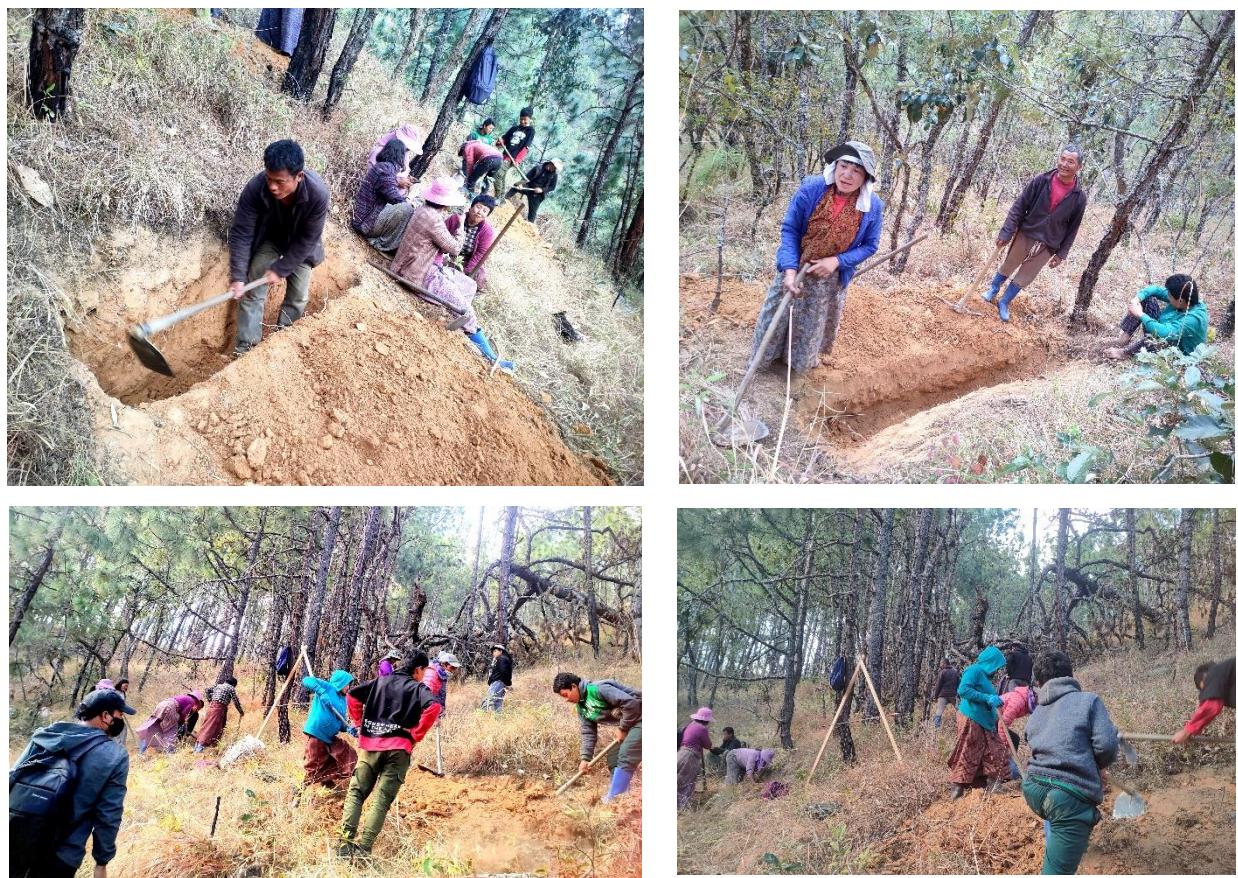
Figure 3.9: Community creating contour trenches on recharge area

The design of the trenches was adjusted based on the slope of the land. Shallower trenches were dug in a staggered manner on recharge areas with slopes between 30 and 45 degrees. The spacing between rows of trenches was kept approximately 5 to 10 meters. This intervention is expected to have a total capacity to hold 12 liters of water per filling of all trenches, excluding 30% of the actual capacity kept for the provision of evapotranspiration.

In this project, an intervention was carried out to increase the recharge of the aquifer in the recharge areas of the Lungchuna spring in Chabu. The objective was to capture rainwater and allow it to percolate down into the aquifer, thereby increasing the discharge of the spring. To achieve this, 52 contour trenches were constructed in open spaces with a slope of up to 30 degrees. The trenches were 5 to 10 meters long, 0.6 meters deep, and 0.6 meters wide, and were designed to capture rainwater (ICIMOD, 2018).
